# **Safety Alert**

## **Fall from Ladder**

### Description of Incident (February 18, 2023)

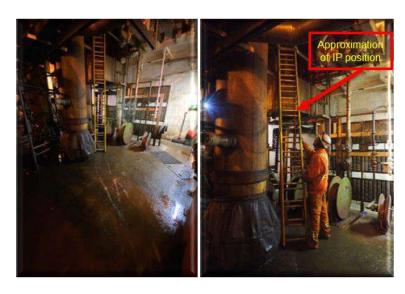
- The ladder was damaged; not identified with pre-use inspection
- Oily deck conditions were present within working area
- Worker bracing the ladder failed to recognize hazard of ladder slipping
- The bottom of the ladder was not tied off to a secure point

Image Description: Position of ladder prior to event

- Inspect all extension ladders and discard those that do not pass inspection
- Update Offshore Induction Form with expectations associated with ladder inspection and use
- Update training on ladder use and expectations
- Evaluate available alternative ladder designs which incorporate additional stabilization features for use offshore
- Update annual ladder inspection program

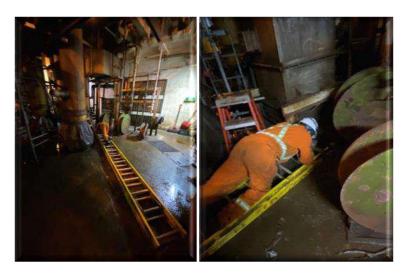
Two inspection technicians were preparing to perform ultrasonic testing inspection on a flowline using an extension ladder. One worker braced the ladder to prevent lateral movement. The injured person (IP) was 2.5 - 3 meters up the ladder wearing fall protection and was in the process of tying off to a nearby structure when the foot of the ladder slipped backwards. The IP maintained their position on the ladder while it fell to the deck. The IP walked to the medic with their co-worker for further assessment where multiple lacerations required sutures to their knees and elbows.

Image Description: Position of ladder following event
